**Type A Accident
Investigation Board Report
on the February 20, 1996,
Fall Fatality
at the
Radioactive Waste Management Complex
Transuranic Storage Area - Retrieval Enclosure
Idaho National Engineering Laboratory**

March 1996

**Office of Oversight
Environment, Safety and Health
U.S. Department of Energy**

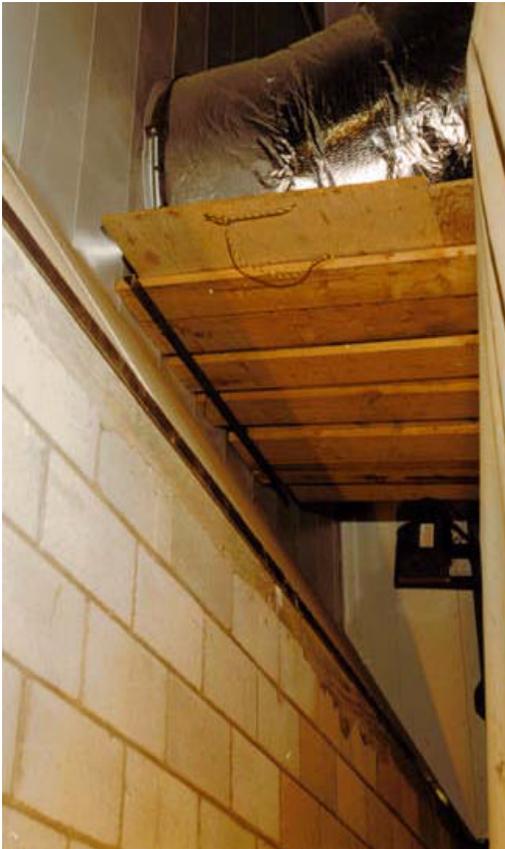
of the accident scene by the ductwork subcontractor, Air-Con, Inc., for use in performing work on the transition piece for the exhaust air system. The platform was made of two 3/4 inch thick plywood sheets (4 feet by 8 feet) laid side by side and fastened to 2 inch by 12 inch wooden supports with screws. The outer 18 inches of the plywood sheets extended over the wooden supports (see Exhibit 2-4). The platform was intended to facilitate bolting of the transition piece and to keep parts from falling into the gap under the

The vendor heard the project engineer fall.

platform. It was not intended to be a work platform without 100 percent fall protection, and had no guardrails, toeboards, or other fall protection installed. The only lighting available in the area of the accident was ambient light from open rollup doors on the west side of the building. Illumination in the area of the platform was 2 foot-candles.
